Royal Borough of Windsor and Maidenhead

Wraysbury Drain Ecology and Geomorphology Assessment

Project:	Horton and Wraysbury Drain		
Client:	Royal Borough of Windsor and Maidenhead	Project Number:	B0865900
Document Title:	Wraysbury Drain Ecology and Geomorphology Assessment		
Ref. No:	B0865900/FloodRsk/1000/Wraysbury Drain/01

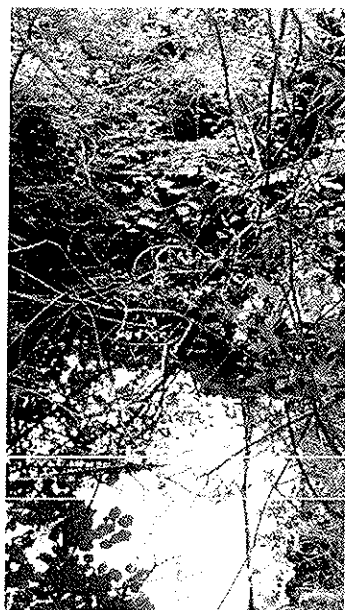
A number of mature and semi-mature trees were observed to be overhanging into the channel, including poplar (*Populus spp*), oak (*Quercus robur*), ash (*Fraxinus excelsior*), sycamore (*Acer pseudoplatanus*) and willow (*Salix spp*). In the upstream section of the reach, a 10m portion of the bank had lifted and fallen towards the Horton Drain (Photo 2).

Photo 1: Over-shaded channel adjacent to the dive lake

Tree maintenance may be necessary to reduce the amount of channel shading, remove the risk of trees falling into the channel or to remove low-growing limbs that accumulate floating debris in high flows. It is recommended that, if required, the younger trees are removed to open up the canopy and allow some light into the drain. Coppicing is preferred over felling and all these works would rely on the ecological quality of the tree. A rotation of coppicing along a river could help to

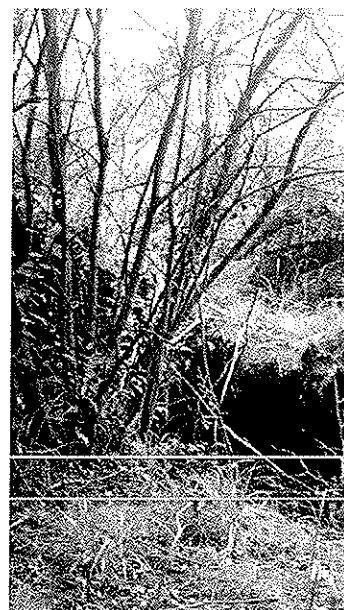
Photo 2: Section of bank lifted where tree has fallen

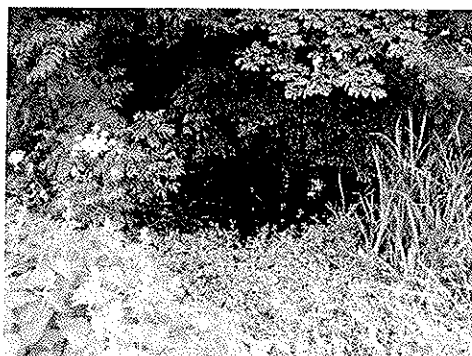
Reach 2 was surveyed twice, approximately a month apart. During the first survey a small portion of the channel (approximately 1m wide) had water in it suggesting a low flow channel had formed (Photo 5). During the second site visit, there was no water evident in the channel.

Photo 5: Low flow channel during first survey

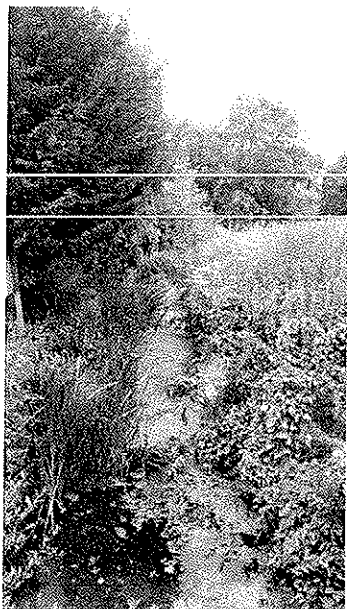
Photo 6: In-channel vegetation, with concrete bank reinforcement on the right bank and tall ruderal vegetation on the left bank

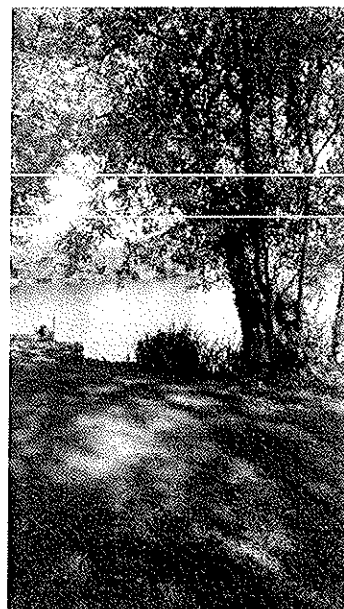
Photo 7: Looking from the drain to the Wraysbury No1 Gravel Pit SSSI

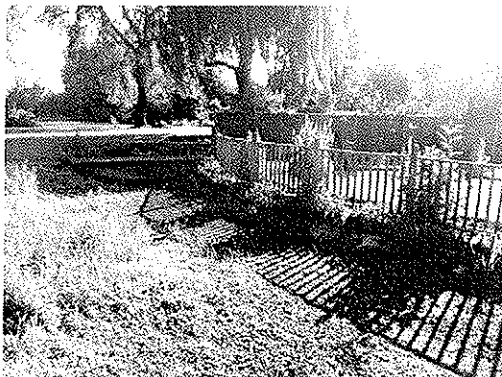
predominantly being reinforced (Photo 8). The drain had no water in it at the time of survey, with parts of the drain choked with in-channel vegetation. Other sections of the drain had been cleared by local residents. A number of mature and semi-mature trees lined the gravel pit.

Photo 8: The mid-downstream section of reach 3 running adjacent to gardens

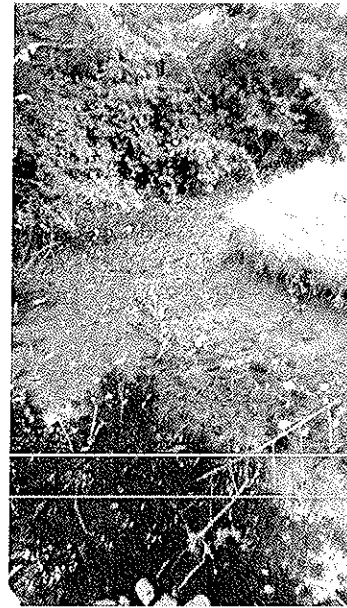
Reach 6 flows adjacent to a number of properties and is similar to reach 3. The channel typically had a reinforced left bank at the toe of the gardens with dense scrub and trees on the right bank (Photo 12). A secondary channel had been constructed creating a circular feature at the upstream extent of this reach, where pooling of water was noted (Photo 13).

Photo 13: Secondary channel feature, with some ponded water

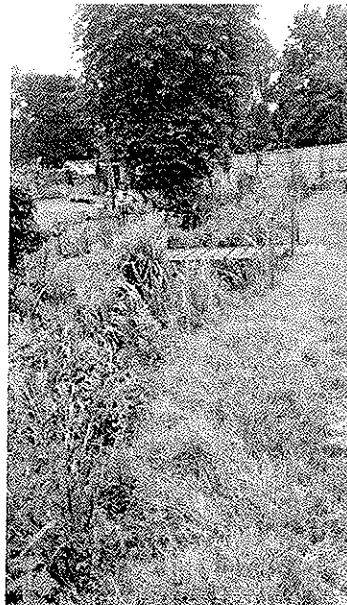
Photo 14: Dense in-channel vegetation within a uniform channel

In some areas the drain was noted to be densely choked with vegetation preventing the conveyance of water and potentially enhancing the deposition of fine sediment. The removal of stands of in-channel vegetation could help to locally improve channel processes. The removal of vegetation in the centre of the channel, retaining some areas of marginal growth, would concentrate the flow into the centre of the channel at the natural low point. It is not recommended that the in-channel vegetation is completely removed, as some vegetation is beneficial. Coupling this work with tree planting could also provide greater longevity of the works and require less regular maintenance. It is recommended that in-channel vegetation is removed by hand.

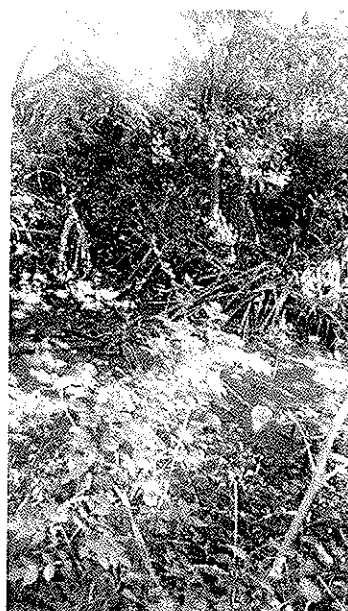
The drain in reach 8 typically had no water (Photo 15); however, some areas had ponded water, probably a result of the last high flow event. There was debris and fly-tipping in parts of the channel (Photo 16). The drain was surrounded by broadleaved woodland, with species present including beech (*Fagus sylvatica*), alder (*Alnus glutinosa*), oak, elder (*Sambucus nigra*), hazel (*Corylus avellana*) and ash. There was minimal marginal vegetation but the channel was heavily shaded by the overhanging trees. A man-made culvert/bridge was observed to be present along this reach.

Photo 15: Channel with no water adjacent to the fishing lakes

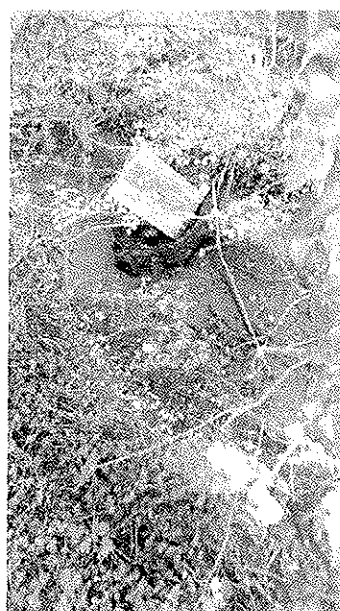
Photo 16: Fly-tipping and in-channel debris

It is recommended that where possible any substantial areas of man-made debris are removed from the channel. The natural bed substrate should be maintained and this should be achieved from the bank where possible to minimise disturbance to the channel.

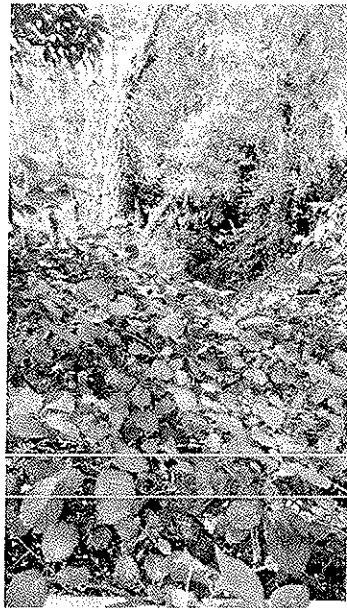
Photo 19: Spot check 3

Spot check 3 (Photo 19) was carried out from a bridge on a local access road. The Wraysbury Drain had a dry bed. The channel was recorded to be approximately 3m wide at bankfull and 1.5m bed width. The channel bed was covered in leaf detritus and small branches from the surrounding overhanging trees and scrub. The right bank was steep and covered in ivy, with the left bank covered in nettles and scrub with a number of mature ash trees situated close to the bridge.

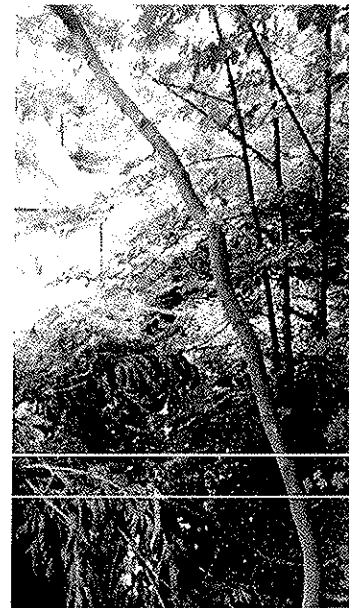
Photo 20: Spot check 4

Spot check 4 (Photo 20) was carried out from a bridge. The Wraysbury Drain at this location near its confluence with the Horton Drain was recorded to be approximately 4.5m wide at bankfull and 2m at bed width. There was standing water within the channel, likely to result from the last high flow event in the Horton Drain. The drain banks were noted to be steep on the right bank with young stands of ash and horse chestnut overhanging the channel. The view of the channel was restricted due to panelling running alongside the bridge.
